# **The Mirador Mine in Ecuador**

## **Another disaster waiting to happen.?**

### **The Mirador Mine**

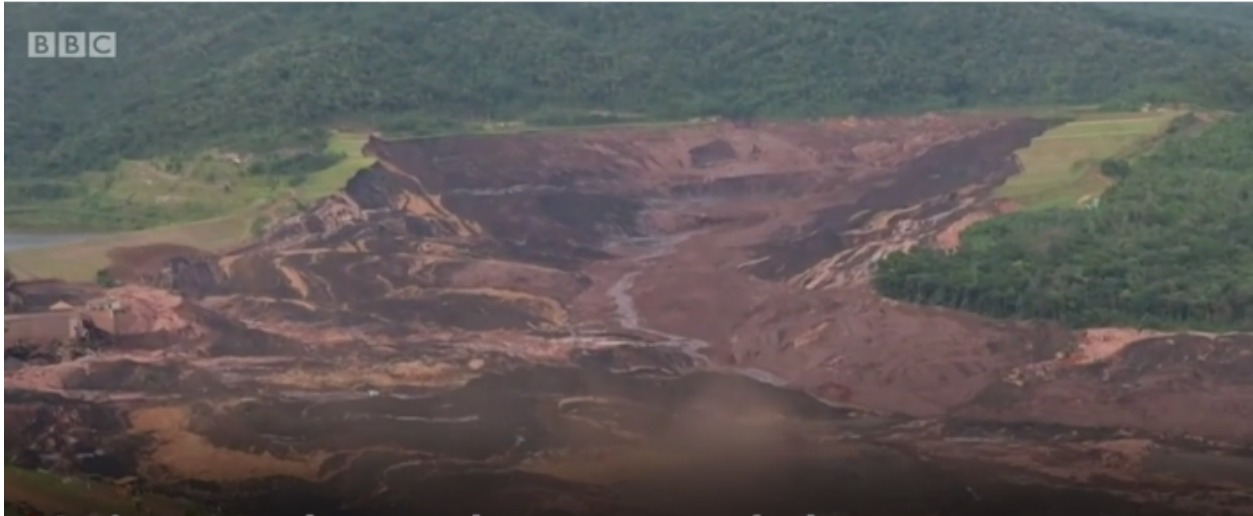
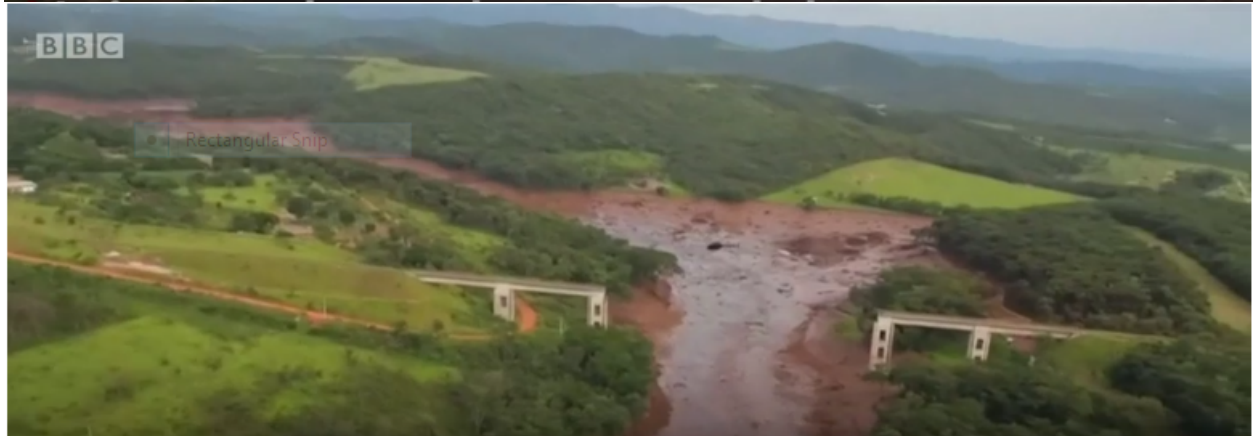
On Friday, January 25<sup>th</sup>. 2019, the 42 year old Brumadinho Tailings Dam in Brazil collapsed. On January 30<sup>th</sup>. news outlets declared that 99 people had been found dead, and the chances of finding a further 259 people missing were declared slim. Vale, one of the world's biggest mining companies, has had \$3bn frozen from its accounts to pay damages, fines, penalties and the funding of recovery work. Five arrests have been made.

The environmental damage will not only affect this generation. The killing of Nature by poisoning is like killing ourselves. Can we put a price on that.?

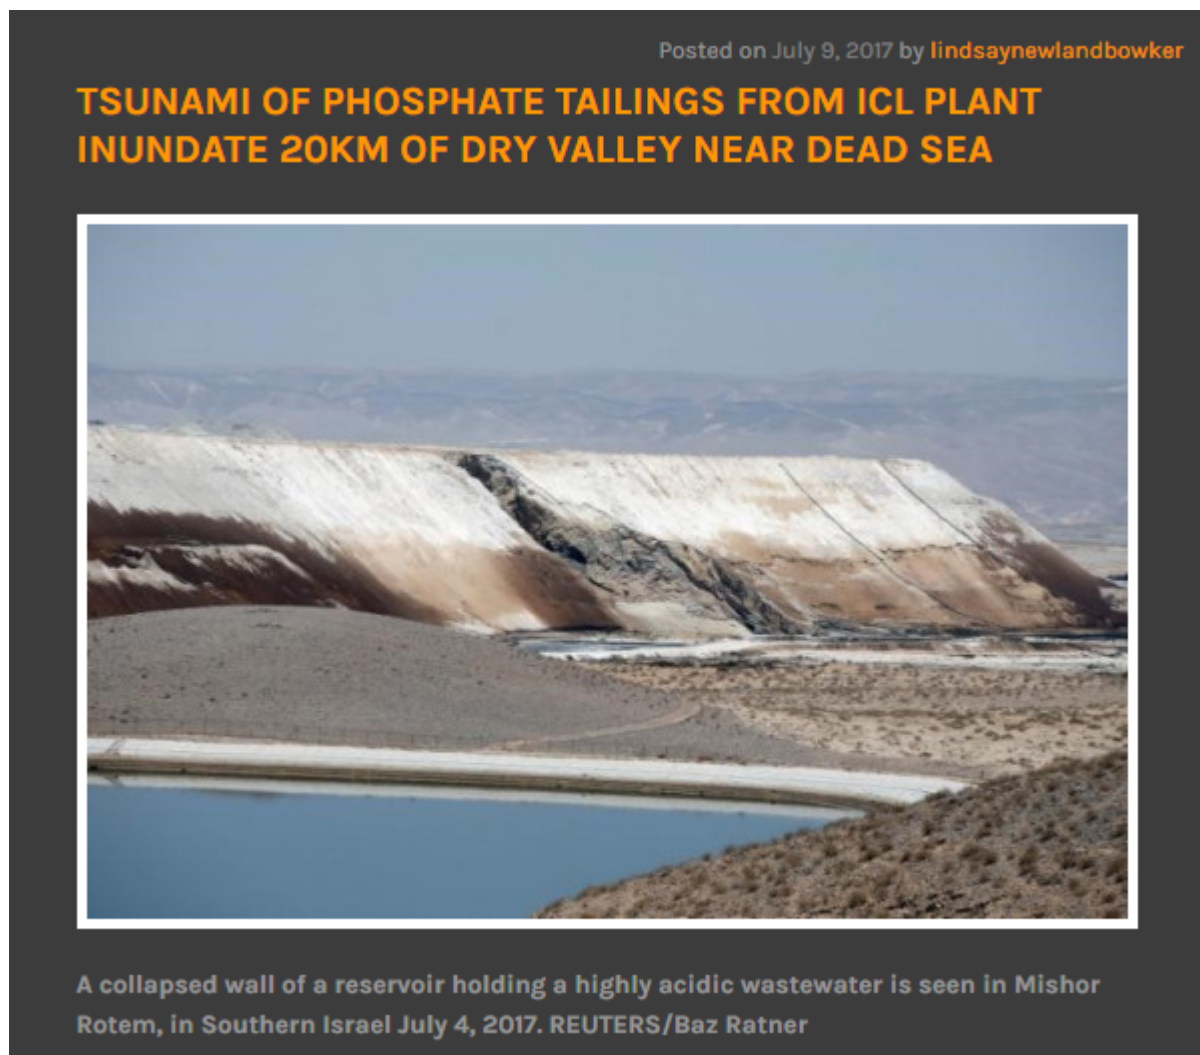
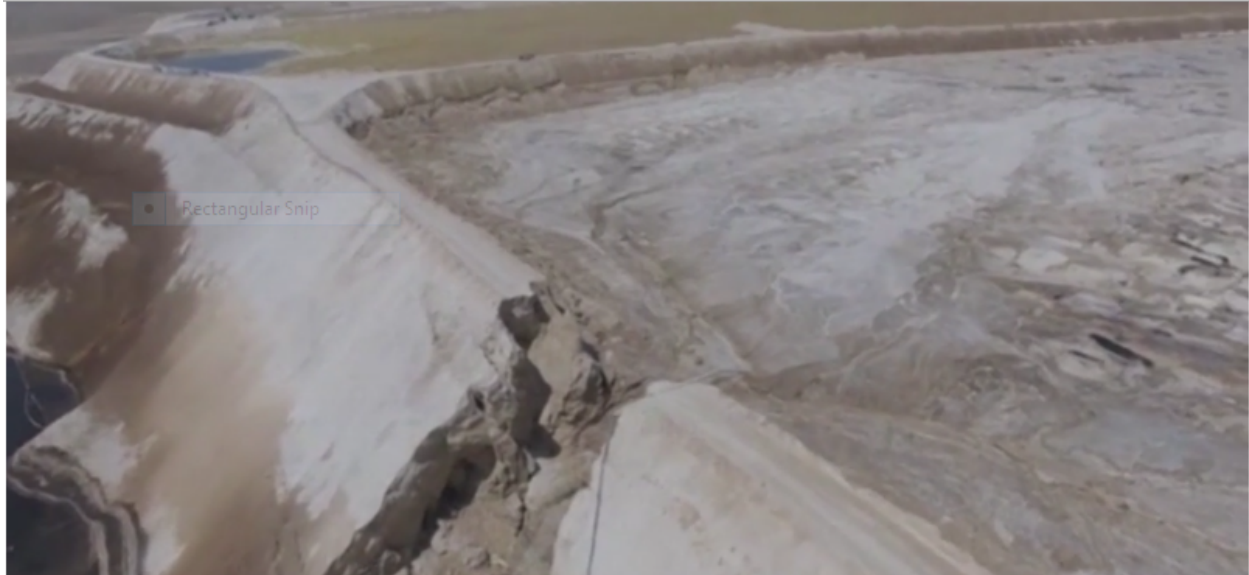
### **The Mishor Rotem Dam Collapse 2017**

“Israel Chemicals first identified the spill at 11:45 a.m. on Friday (***June 30, 2017***), after workers found a hole in the eastern embankment”. This a clear example of piping.

You can see in the above picture the incredibly steep slope of the dam wall.

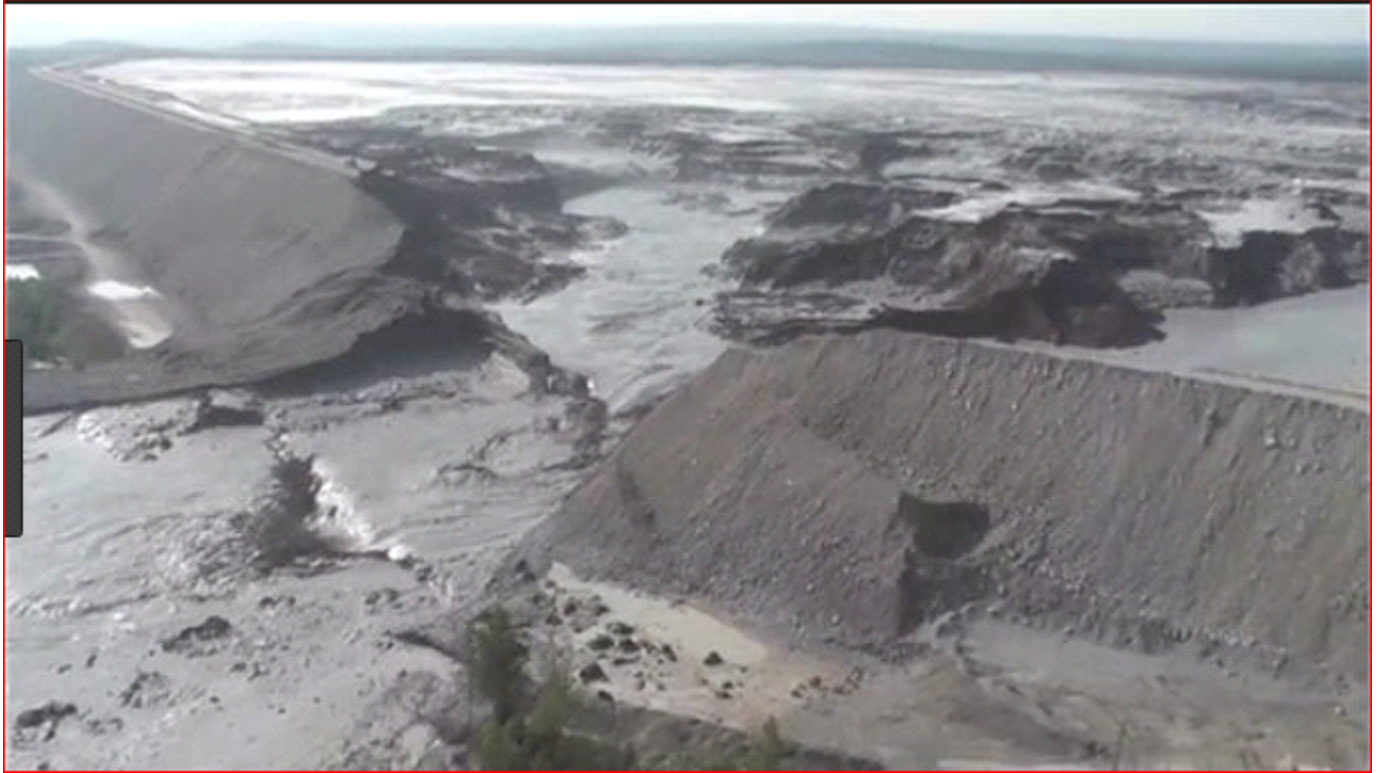
### **The Mount Polley Collapse 2014**

The above picture is of the **Mount Polley collapse in 2014**. This was caused by foundation collapse. The steep embankment and excess water were contributing factors leading to the most serious environmental disaster in Canadian history.

The mine waste travelled into Quesnel Lake, the deepest freshwater lake in the world, a depth of 1,400 meters. Livelihoods have been lost, fish stocks are decimated and both water and soil remain polluted from the catastrophe.

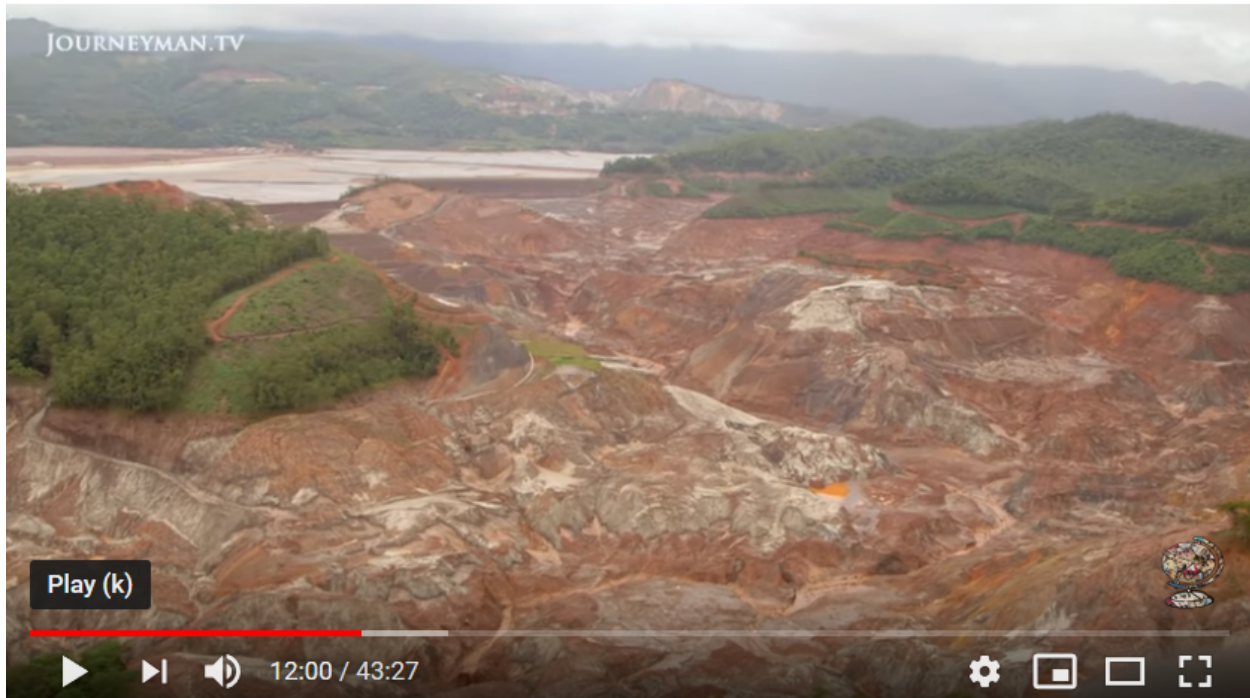
**The Fundao collapse in 2015** occurred when the contents of the dam turned to liquid. The collapse was triggered by an earthquake measuring a mere 2.6 on the Richter scale. The dam had been suffering structural and drainage problems for several years prior to the collapse.

19 people died and 6,000 people were displaced. 700 kilometers of river remain polluted, drinking water is polluted. The poison reached the Atlantic and fishermen on the coast are affected as well as the towns and villages and Indigenous peoples along the whole length of the river.
